January 2016 NEWSLETTER

Proposed Track Relocation, Carson Park, Eau Claire, WI

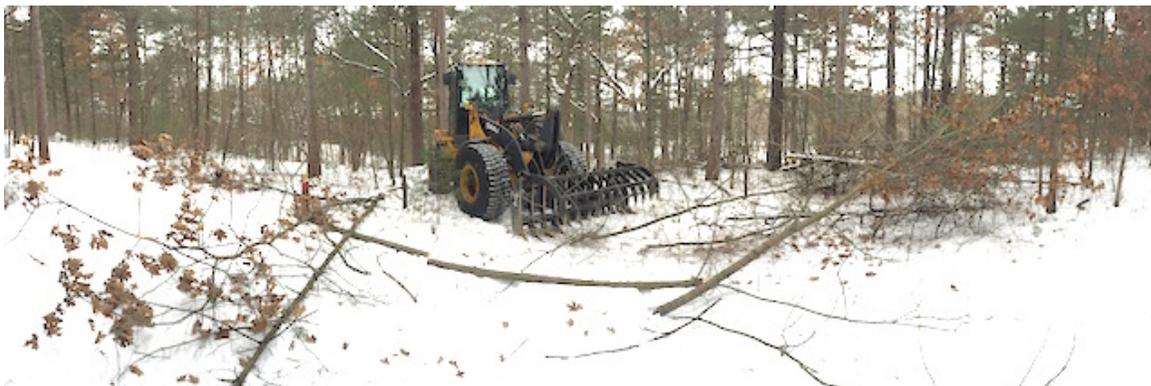
The City Parks Department has removed the trees for the new track right of way. The picture below shows the beginning of the work a week ago.

Brushing Equipment. The City sent in the big stuff to clean up the new right of way. Most of the brush removed was scrub and invasive species like buck thorn and one cork tree. All the white pines were not touched. The crew worked quickly and were very interested in the proposed track work.

Over the next few months the right of way will be graded for track laying. We will build a new switch that will be installed for the laying of track so the current operation will not be interrupted.

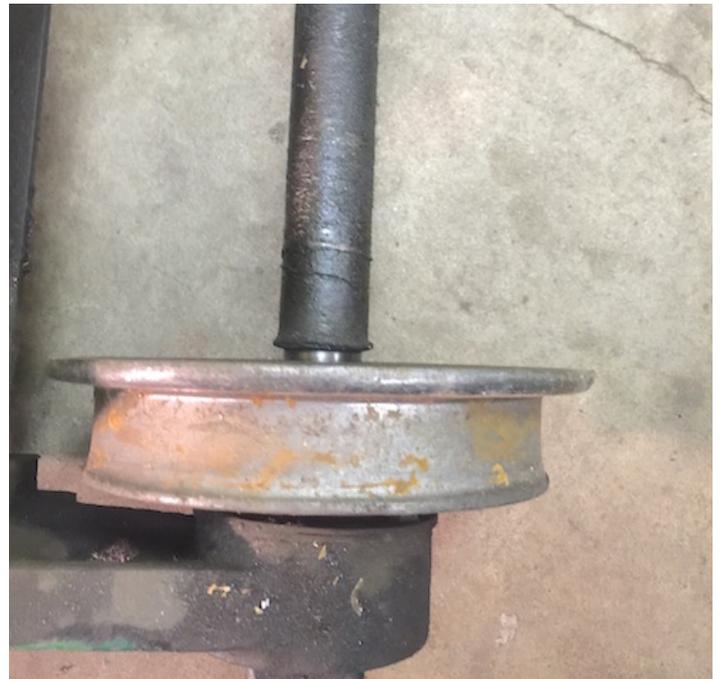
Winter Inspection. Why do we do this? This summer our crew took one of our coaches out of service because of an unusual wheel noise. During our January work sessions we brought the car in for inspection. Upon inspection, a failed wheel was discovered. It was loose on the axle and was wearing badly. Since our crews are alert, the car was set aside for later inspection. This coach has now received a complete inspection and correct profiled wheels have been installed on both trucks.

Sandley Coaches. Both Sandley coaches have been in the shop this winter. Each have received door work. Each has had their trucks and wheels inspected and reproofed. The failed wheel seen above has been replaced.
